OVERVIEW

In June of 2006 a 10-story, 110 unit condo complex suffered a broken water supply line in a 9th floor unit, with water draining down primarily inside wall cavities. The leak was not discovered and stopped until about 16 hours after it started, resulting in extensive water damage to common areas on nine floors and to 17 individual units.

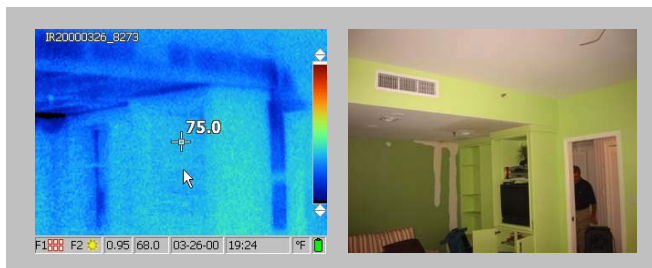
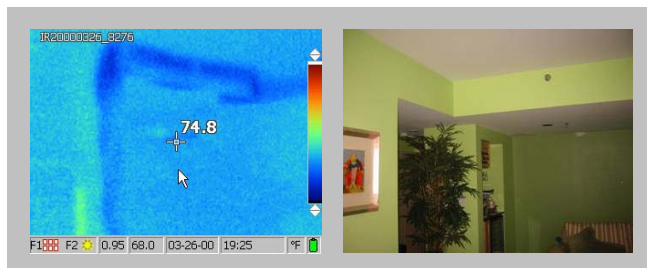
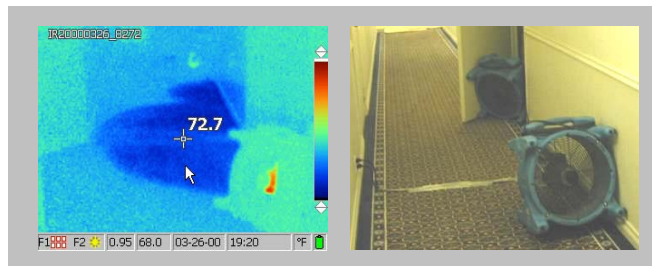
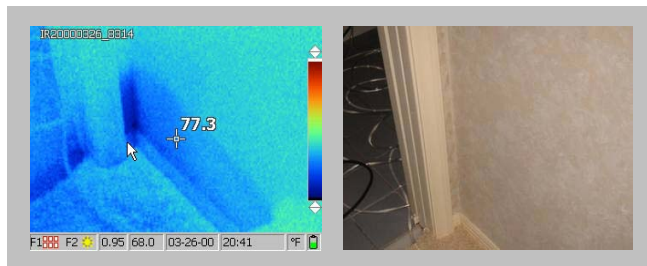
IET worked with the water damage restoration contractor to determine the exact extent of damage and to develop procedures for drying unusual structural assemblies rapidly enough to prevent microbial growth. Thermal (infrared) imaging was used extensively for this determination and to monitor drying progress.
