Mold on Fiberglass-Faced Exterior Gypsum Board

Tim Toburen
 Consultant
 Indoor Environmental
 Technologies
 Clearwater, Florida

This article is a case study discussion of an Indoor Environmental Technologies (IET)

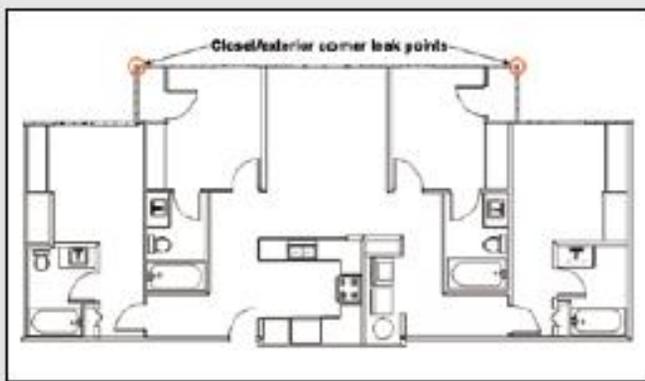
Water accumulated at corners of the center

bedrooms of each apartment, where a closet on the inside corresponded with an exterior corner on the outside. The steel framing track ended at this point, so water ran out of the track onto the floor slab. Minimal ventilation in the closets contributed to mold growth. Water also ran down inside the walls from floor to floor at exterior corners, increasing the moisture load on

lower floors (see Figure 1 on page 26).

Figure 1: Typical apartment floorplan showing leak points at corners.

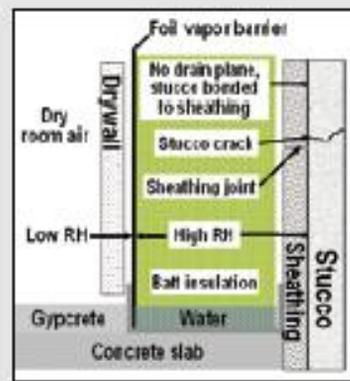
Investigation found water often entered through cracks in the stucco or at other points, penetrated through joints in the sheathing, and then ran down its interior face. A U-shaped steel track at the base of the framing collected and held water. Lightweight concrete (gyperete) used to level the floor raised the floor surface in the adjacent room 1” to 1.5” above the concrete slab, keeping water inside the wall instead of letting it run out onto the floor (see Figure 2 on page 26).

Fiberglass batt insulation in the exterior wall cavities was faced on the inside with an impermeable foil. Materials on the interior side of the foil, such as the drywall, were at equilibrium with the dry air, 45% to 55% RH, inside the building. Air and materials on the wall cavity side of the foil vapor barrier equilibrated

with the water standing in the track at the bottom of the wall (often over 85% RH). These materials (such as steel framing, insulation and sheathing), are non-absorptive. They provided no hygric buffer that might have allowed minor leakage to occur without excessive humidity developing (see Figure 2).

Figure 2: Diagram of cross-section through typical wall.

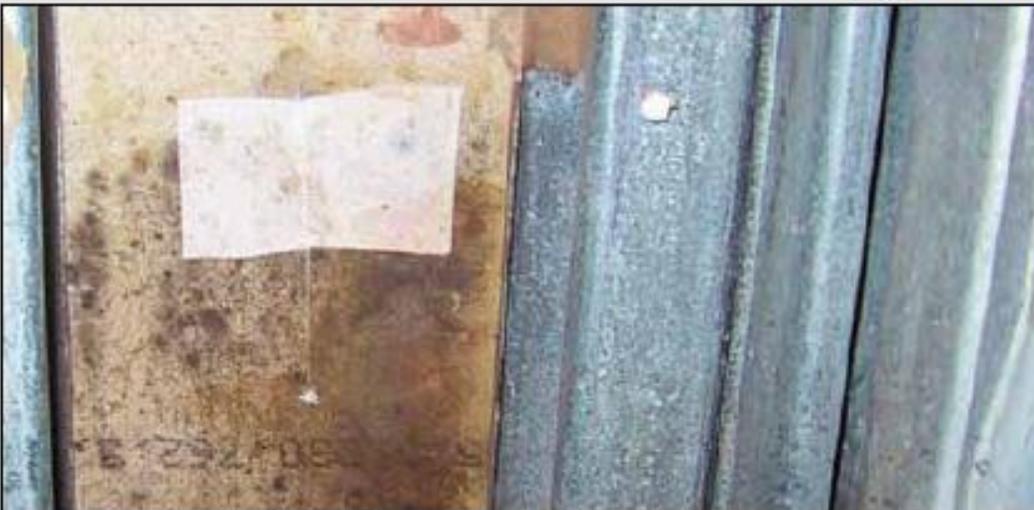
The materials in the wall cavity between the foil and the exterior wall do not provide a food source for mold growth, and are therefore considered highly mold-resistant. Moisture conditions in this case appear to have been so extreme that mold growth nevertheless occurred in fiberglass insulation and on the fiberglass face of the gypsum board sheathing. Heavy mold growth (including *Stachybotrys* and *Acremonium*) was found in numerous locations on the sheathing. We speculate a food source was provided by soils deposited on surfaces during

construction and in solution in the moisture that penetrated (see Figure 3 on page 26).

Figure 3: Bulk sample from visible mold growth in fiberglass-faced sheathing. Heavy *Stachybotrys* and *Acremonium* growth found.

A protocol for each area was written, containment was erected, then demolition and detailed cleaning were performed. Removal of affected exterior sheathing was impractical, so we specified aggressive cleaning and coating with an antimicrobial encapsulant. IET provided oversight throughout remediation to ensure work was performed properly. Upon completion or remediation, we obtained air and surface samples from each area, submitting them to a third-party laboratory for analysis.

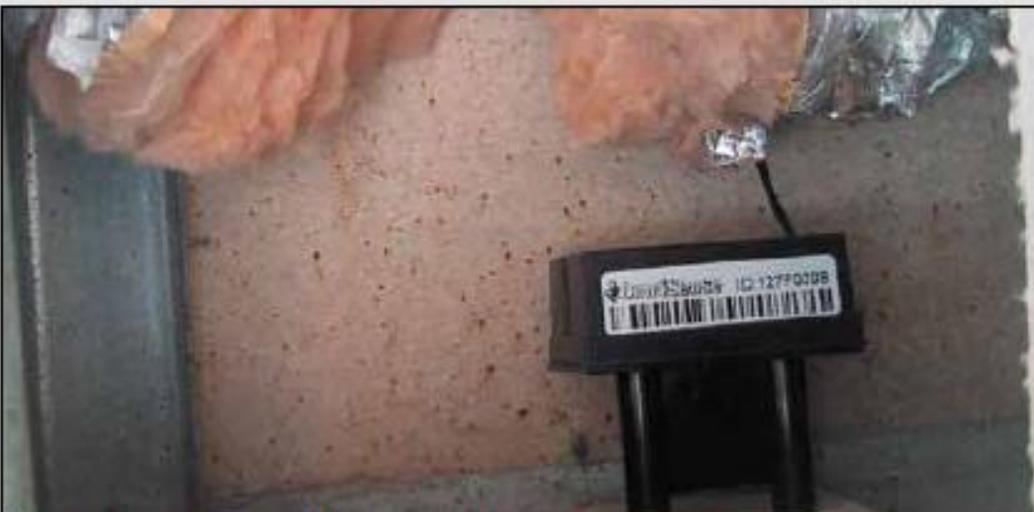
To document that exterior repairs had stopped moisture intrusion, IET installed a remote wireless temperature-humidity-moisture content sensor in an exterior wall cavity of each of the approximately 100 rooms remediated. The sensors connect wirelessly to gateways that send collected data over the internet to a central computer, where it is logged. Users can elect to have alerts sent by email whenever the parameters exceed preset limits. The system can be accessed from any computer and a variety of reports produced (see Figure 4 on page 26).

The sensor system proved the wall repairs to be highly effective at preventing moisture intrusion. The data it provided also alerted building owners to a problem of which they'd previously been unaware: defective or improperly installed windows allowing moisture intrusion even after wall repairs. This gave our client a better understanding of the nature and extent of building issues.

Figure 4: Wireless sensor installed in wood block at base of exterior wall cavity.
